Franklinton Vlaie Tributary Improvement Study

**Technical Report and Recommendations
Town of Broome, Schoharie County, New York
March 2018**

MMI #6108-01-04

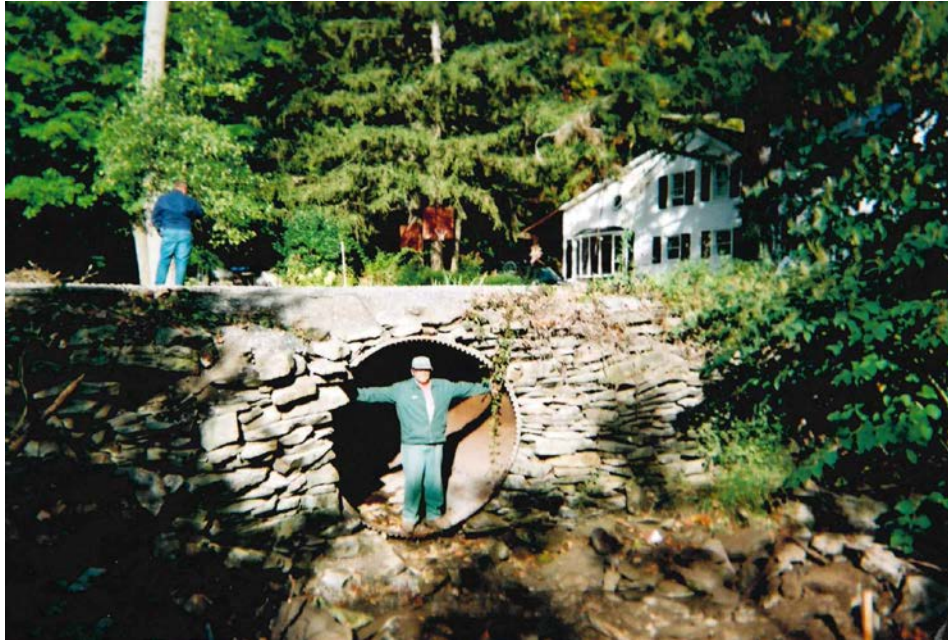
Figure 4-1
6-foot diameter round culvert that preceded existing culvert

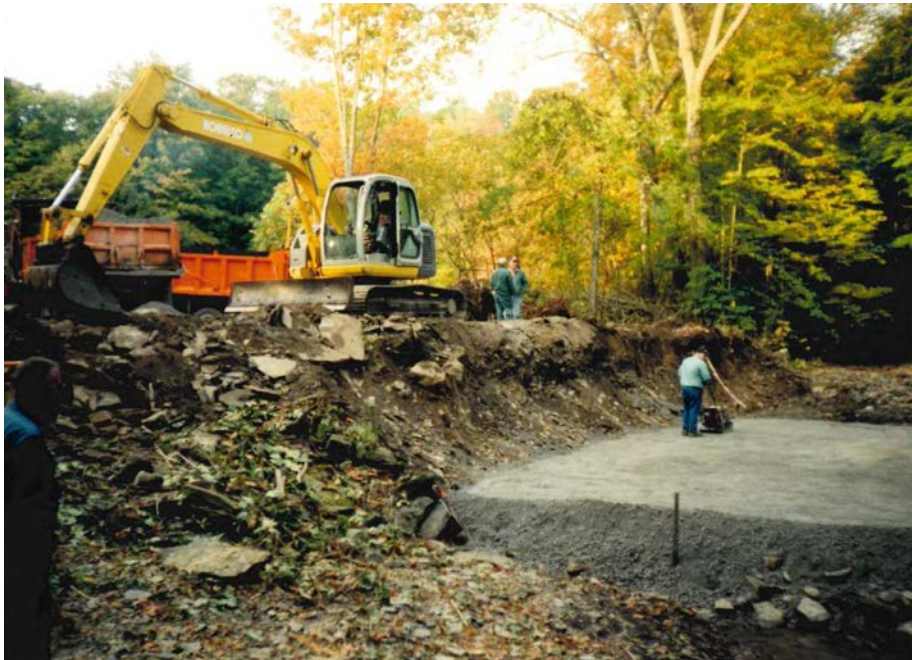
The thick gravel bedding placed over the stream bed during construction of the replacement culvert (visible in Figures 4-2 and 4-3) appears to have raised the culvert and reduced its available head, leaving very little cover between the top of the culvert and the road surface.

Figure 4-2
Existing culvert during construction

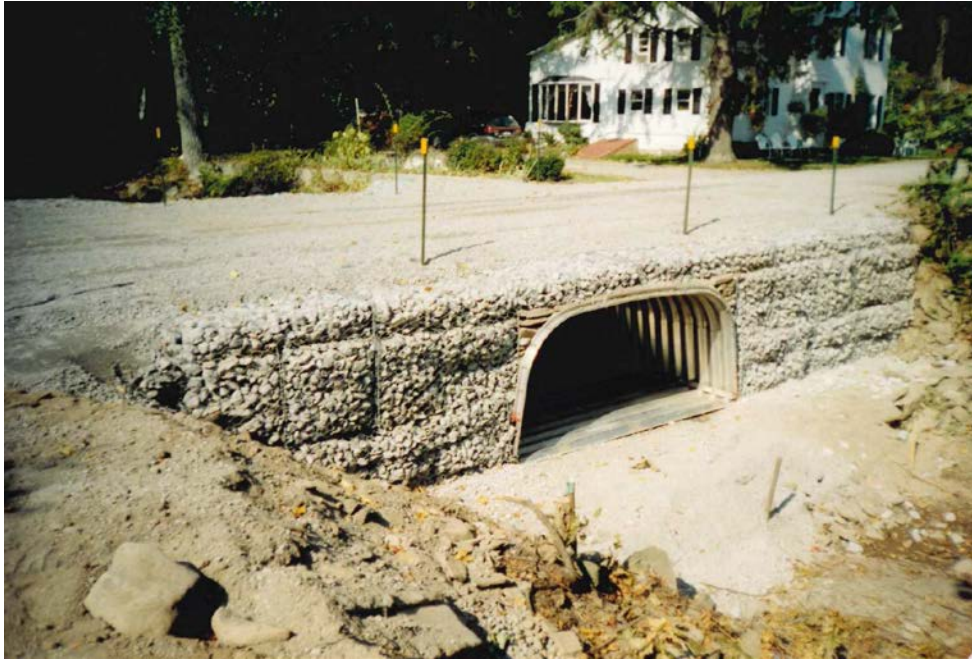
Figure 4-3
Existing culvert during construction, viewed from downstream

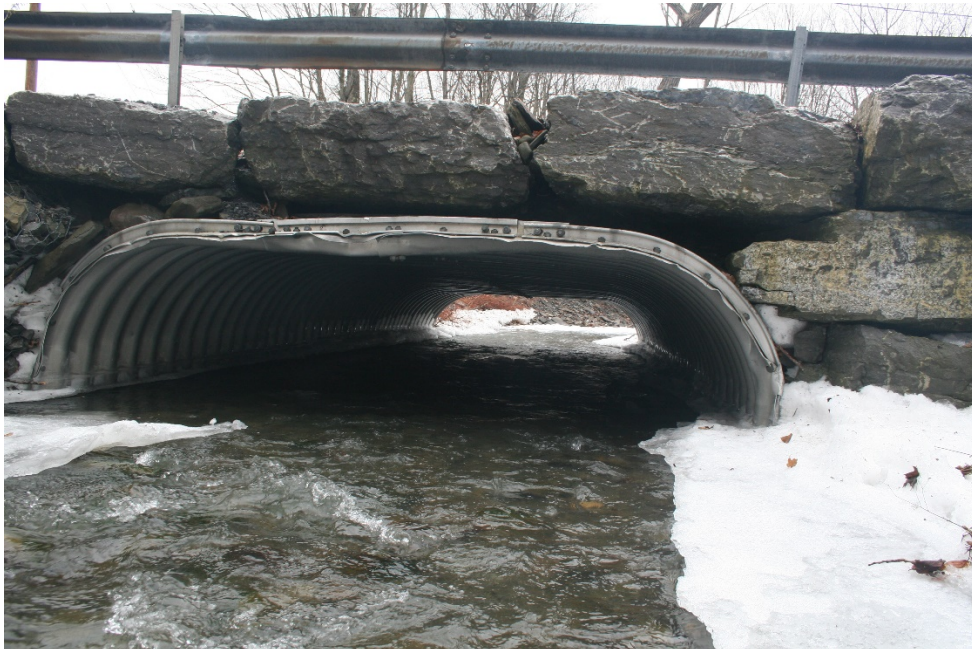
Figure 4-4
Existing Culvert, 2017

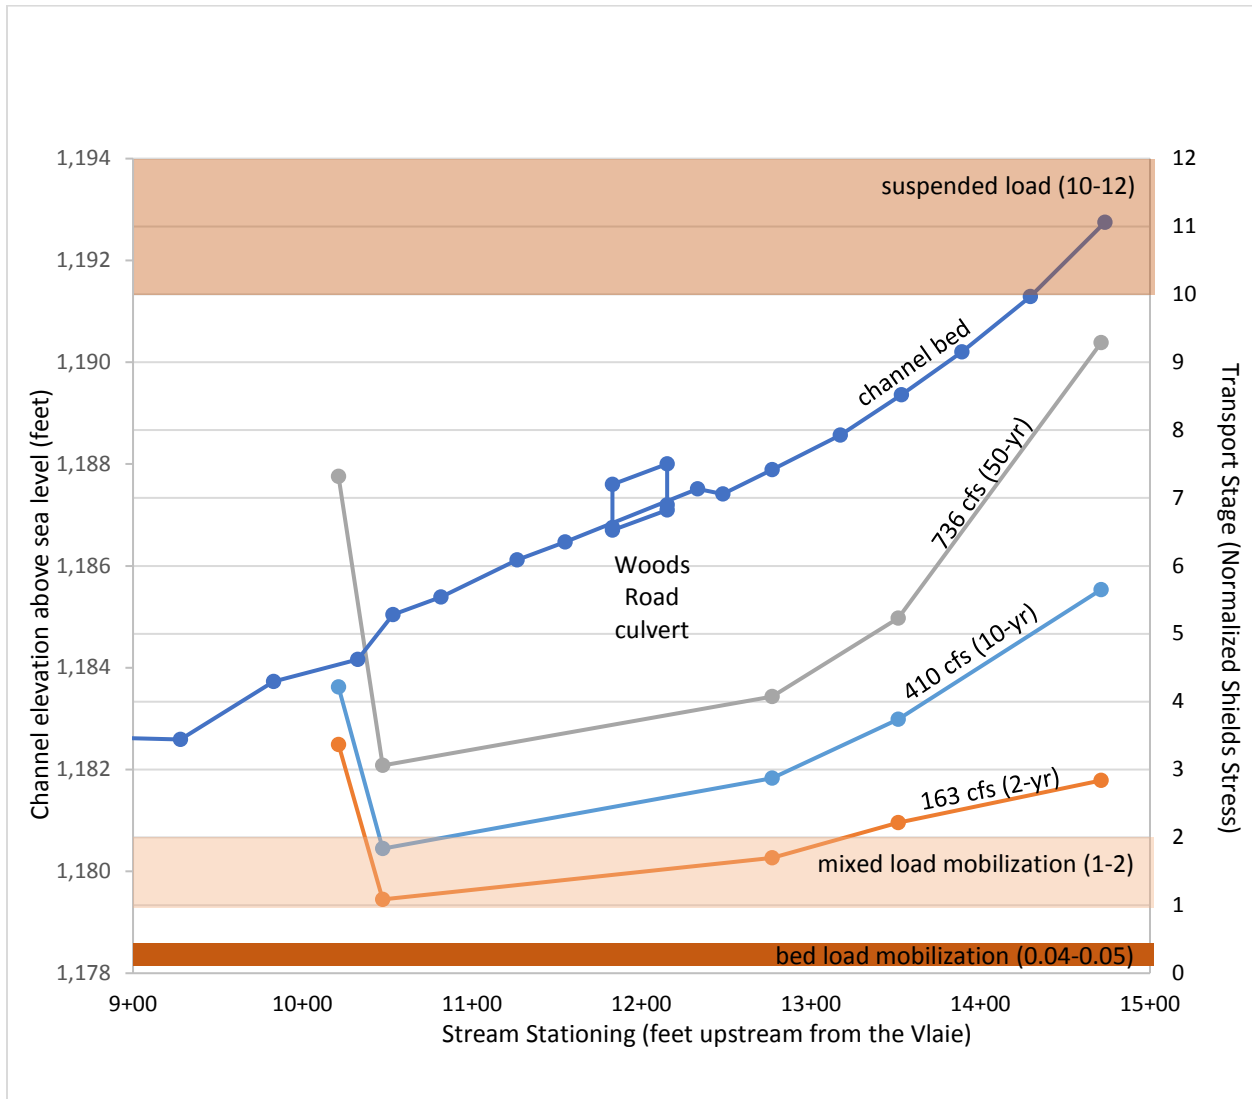
The BAGS analysis indicates strong mixed load transport by the 10-year event, with limited transport at the 2-year event. There is a decrease in sediment transport capacity moving down the channel, approaching, and through the Woods Road culvert.

Figure 5-4
Results of BAGS Analysis

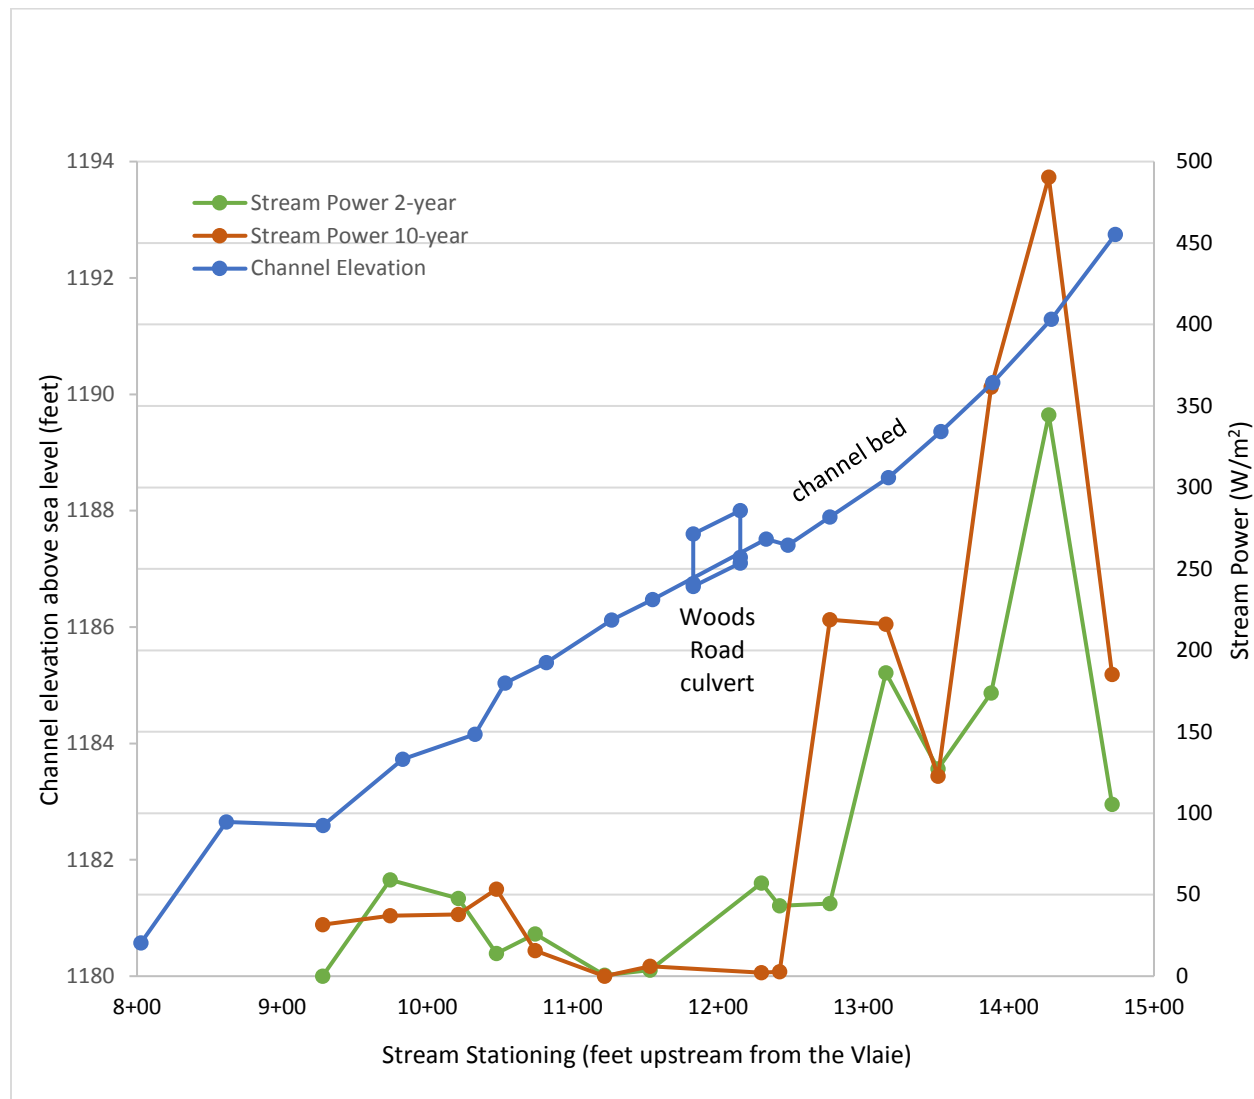
Specific stream power for the 2-year and 10-year flow events and channel profile have been plotted against stream stationing, as presented in Figure 5-5. The plots indicate a decline in steam power as flows approach the Woods Road culvert and the alluvial fan. This decline in stream power is most pronounced during the 10-year flood event, and occurs as water exits the channel and spreads out on the alluvial fan.

Figure 5-5
Results of Stream Power Analysis

Specific stream power upstream of Woods Road is generally higher than stream power through the area of the culvert and across the alluvial fan. This loss of stream power occurs as flows spread out across the alluvial fan. Stream power through the channel upstream of Woods Road during a 2-year flow event exceeds 200 W/m², which is adequate to move medium gravel, but diminishes at the culvert. During larger flow events (i.e., the 10-year flood), stream power is sufficient to transport coarse gravel, although adequate stream power is not maintained through the entirety of the reach resulting in the deposition of this material in the area of the culvert and on the alluvial fan.

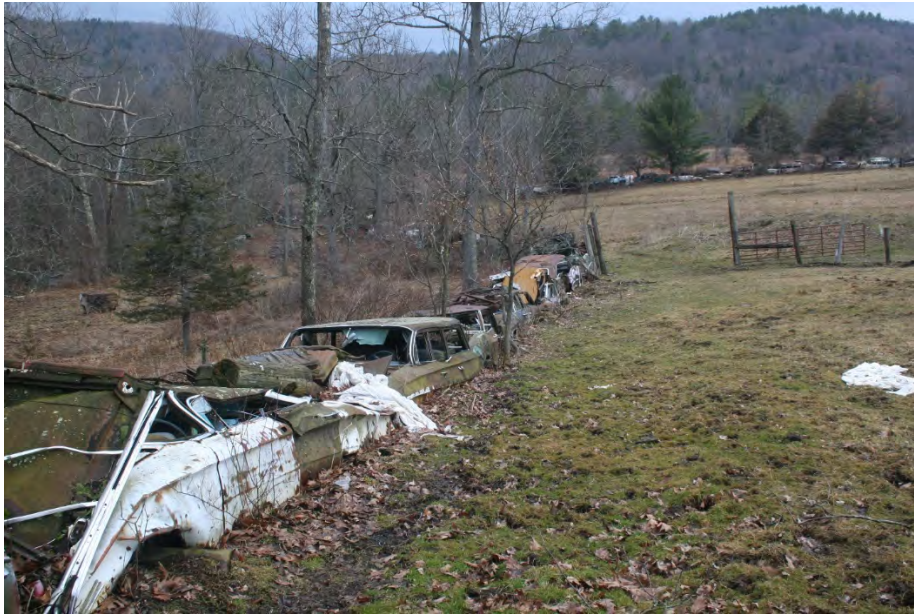
Fencerows constructed from junked cars
March 7, 2017

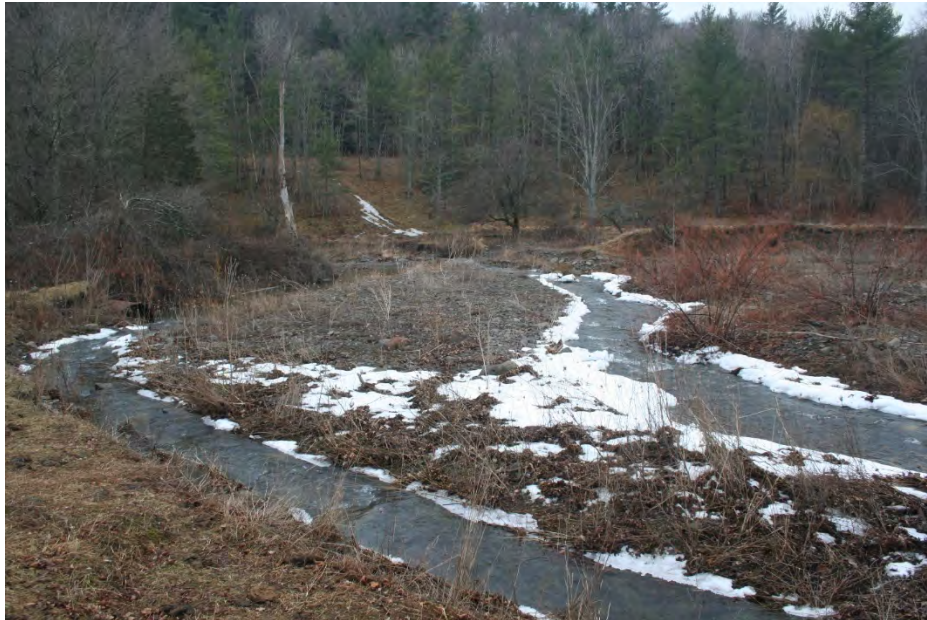
Main Branch at STA 42+00
Unstable wandering channel
March 7, 2017

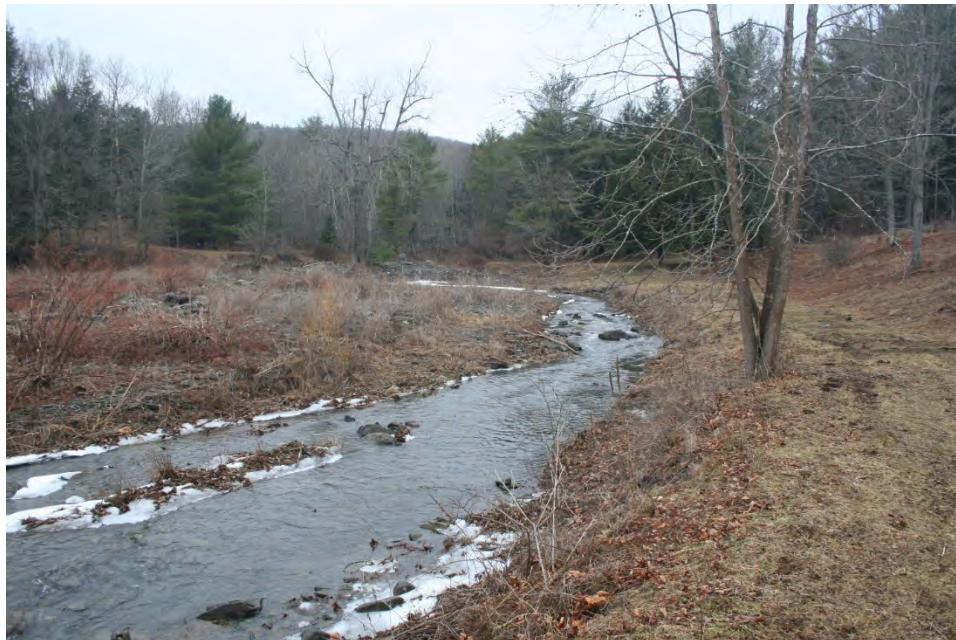
Main Branch at STA 46+00
Unstable wandering channel
March 7, 2017

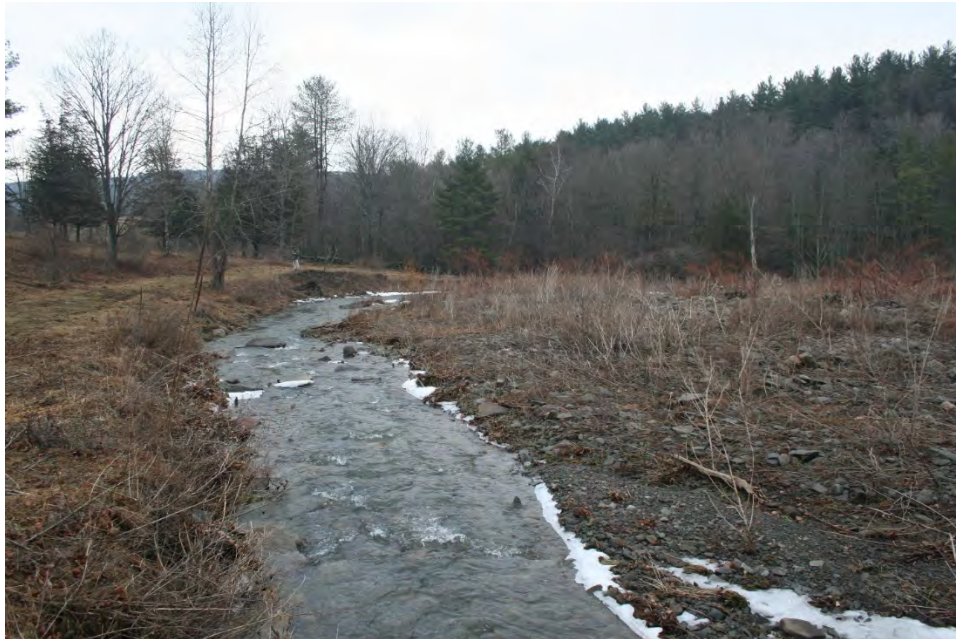
Main Branch at STA 46+00
Eroding bank
March 7, 2017

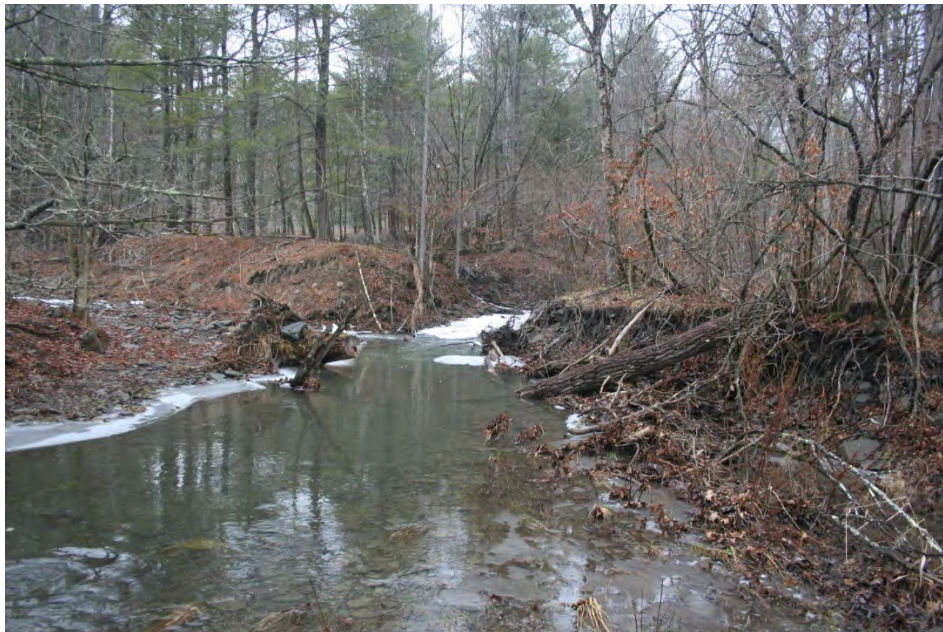
North Branch at STA 3+00
Channel incision
March 7, 2017

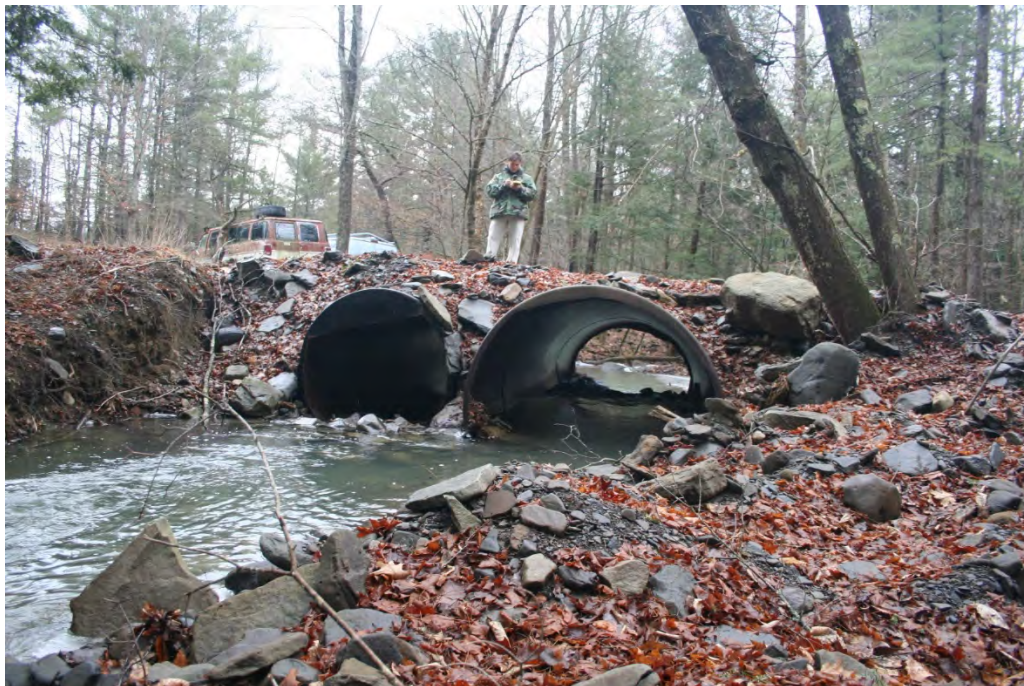
North Branch at STA 10+00
Channel incision
March 7, 2017

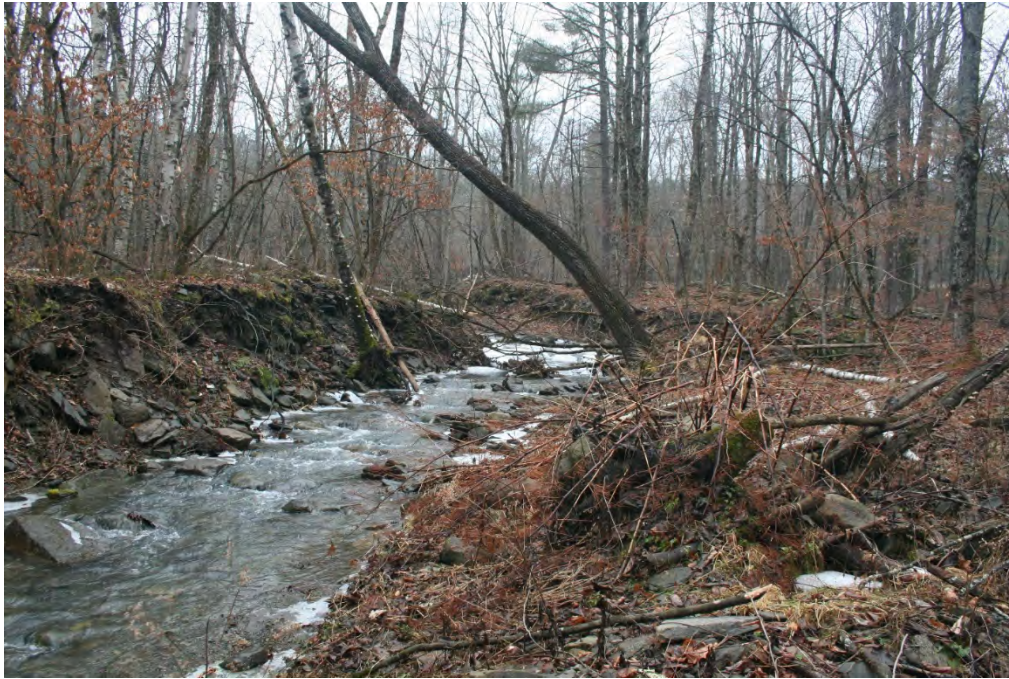
North Branch at STA 10+00
Channel incision
March 7, 2017
