Franklinton Vlaie Tributary Improvement Study

**Technical Report and Recommendations
Town of Broome, Schoharie County, New York
March 2018**

MMI #6108-01-04

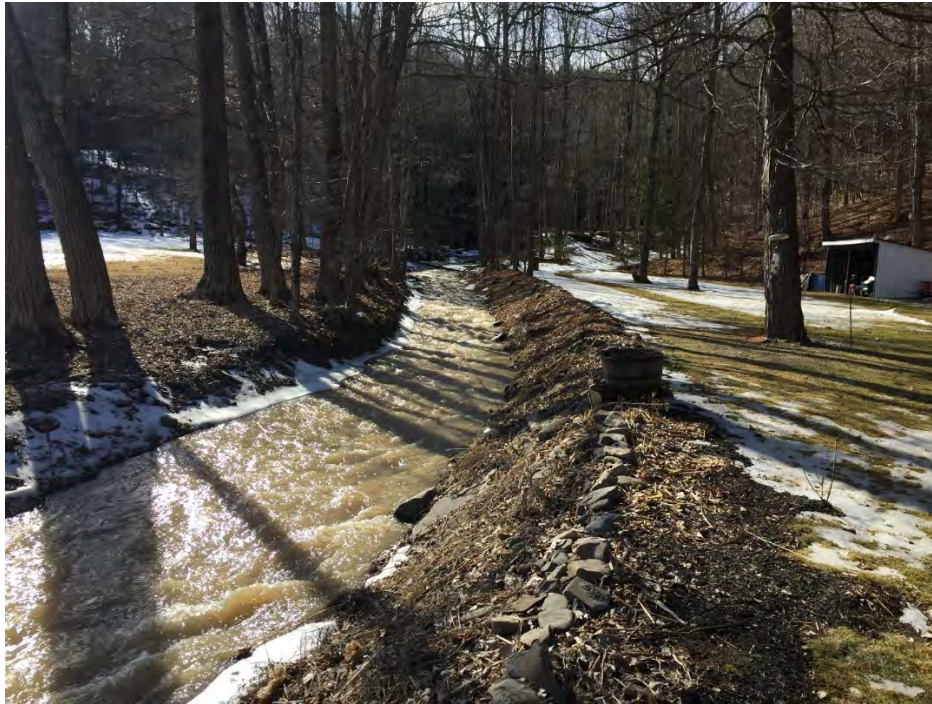
The accumulation of coarse grained sediment (primarily gravel and cobble ranging in diameter from 2 to 64 mm) at the Woods Road culvert has been an ongoing problem. This type of sediment can be characterized as bedload. Bedload is transported down the channel by rolling, bouncing, or sliding along the channel bed when the entrainment threshold is reached. The geomorphic assessment presented in Section 5.0 can be used as a starting point to assess the movement of bedload through the system.

Main Branch at STA 12+00
Woods Road Culvert viewed from upstream
March 7, 2017

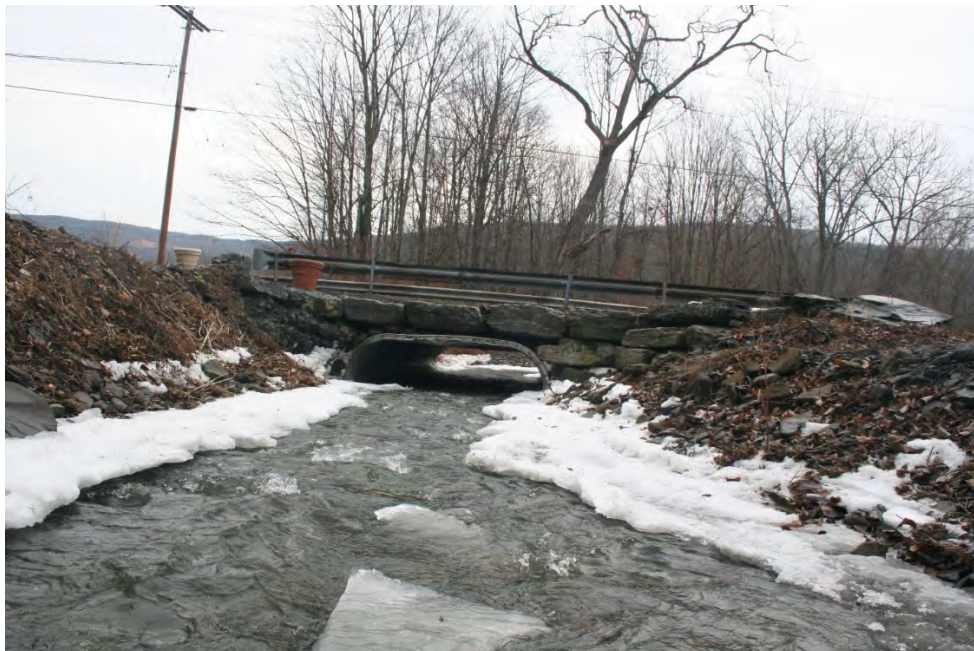
Main Branch at STA 15+00
View looking downstream towards Woods Road culvert

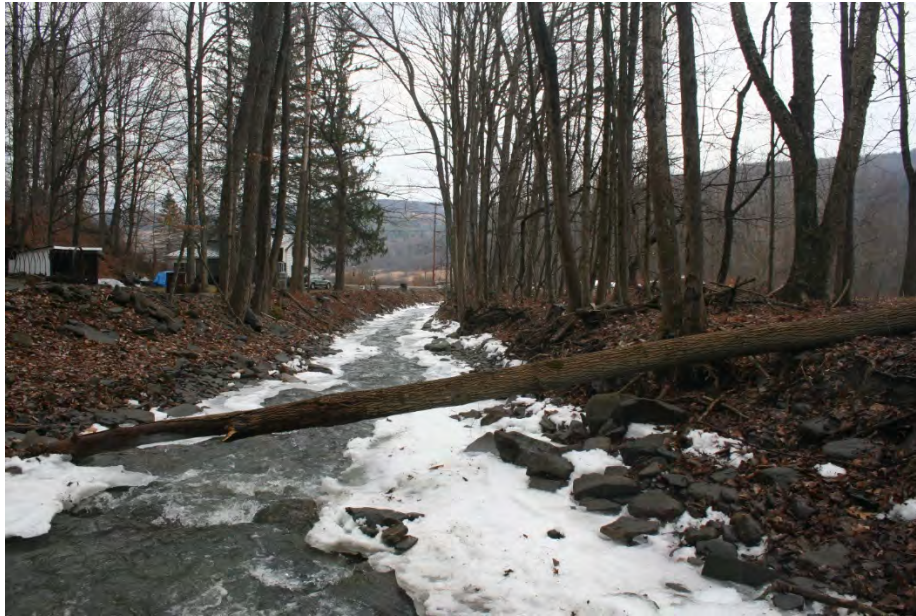
Main Branch at STA 17+00
Falls viewed from downstream
March 7, 2017

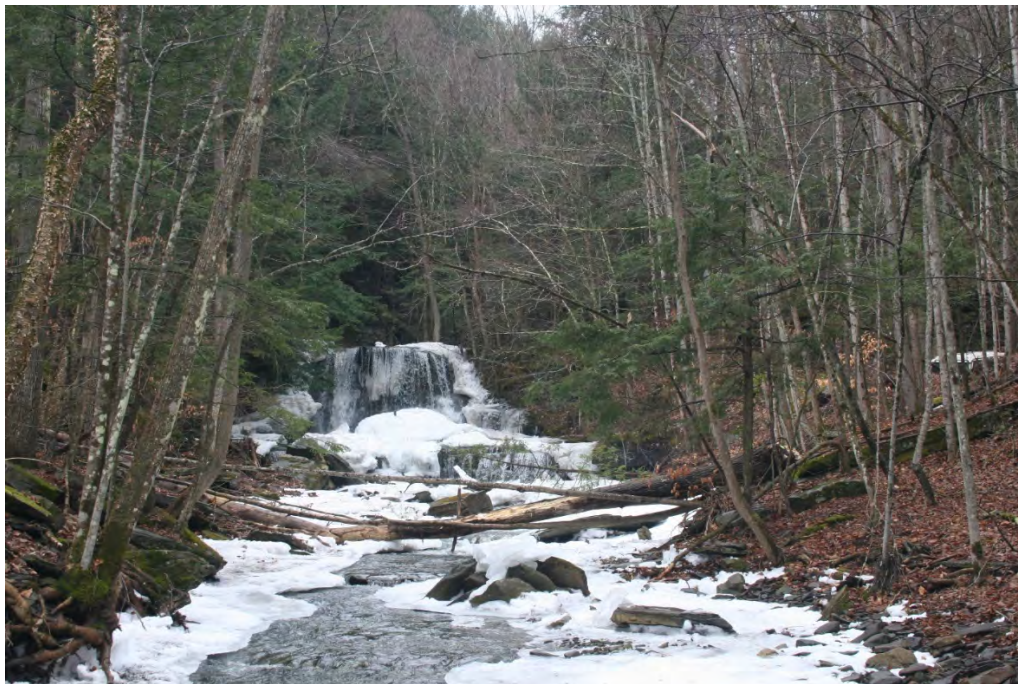
**Main Branch at STA 17+00
Top of Falls**

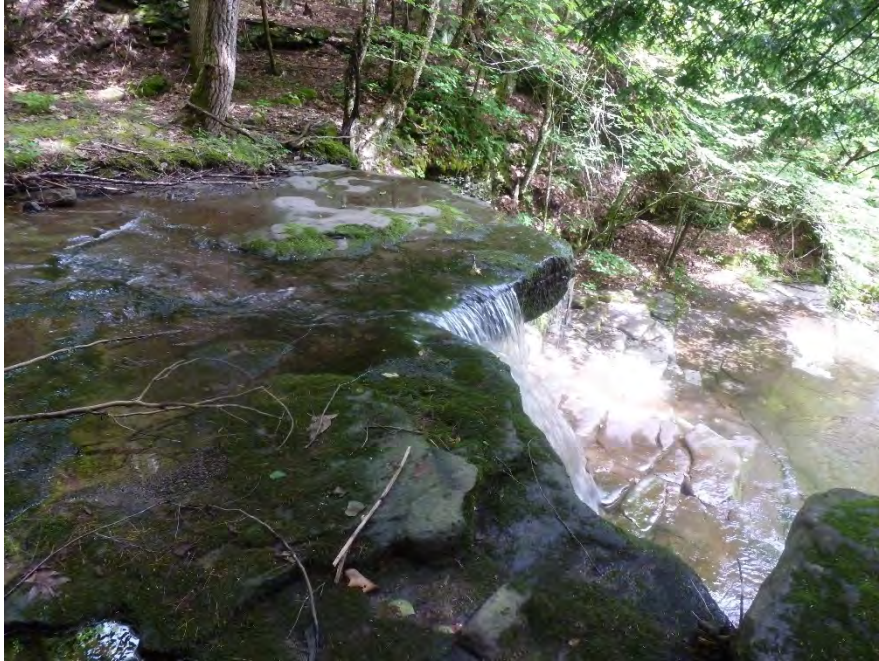
**Main Branch at STA 25+00
Confined bedrock gorge
March 7, 2017**

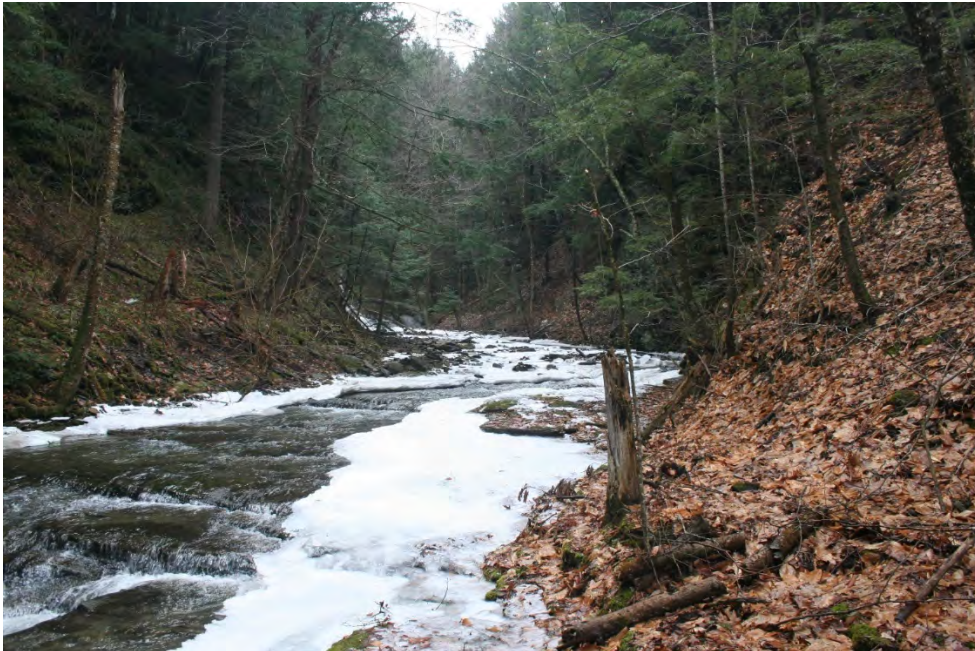
Main Branch in Gorge
Trout in Pool

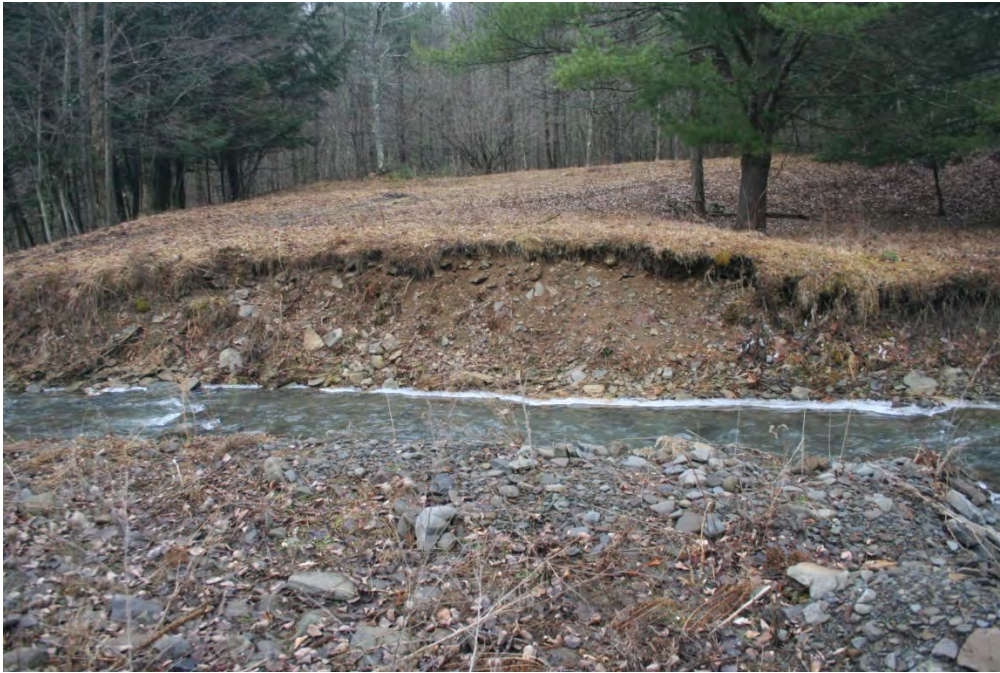
Logging Road crossing Main Branch

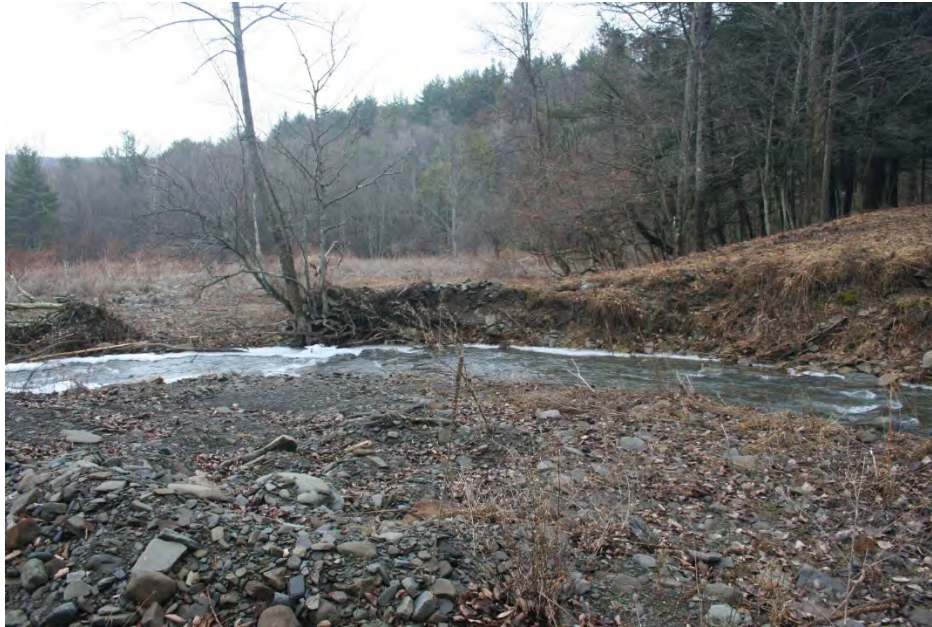
Cattle have free access to much of Catskill Creek and up into both branches, especially the main branch. The large pool at this confluence was turbid with fine-grained sediment deposits. Resultant erosion and wastes are likely to affect certain water quality parameters such as bacteria content and nitrates. In addition, the presence of junk cars along the top of the stream bank may contribute to water quality contamination from leaked fluids or breakdown of car body parts.

Main Branch at confluence with North Branch at STA 47+00
March 7, 2017

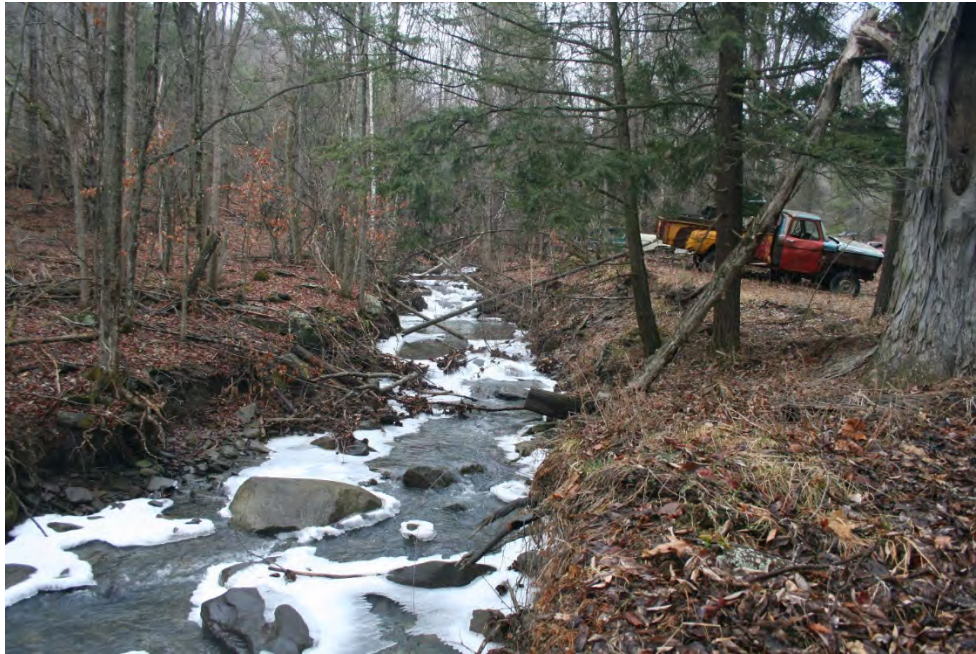
North Branch at STA 5+10
Channel crossing
March 7, 2017

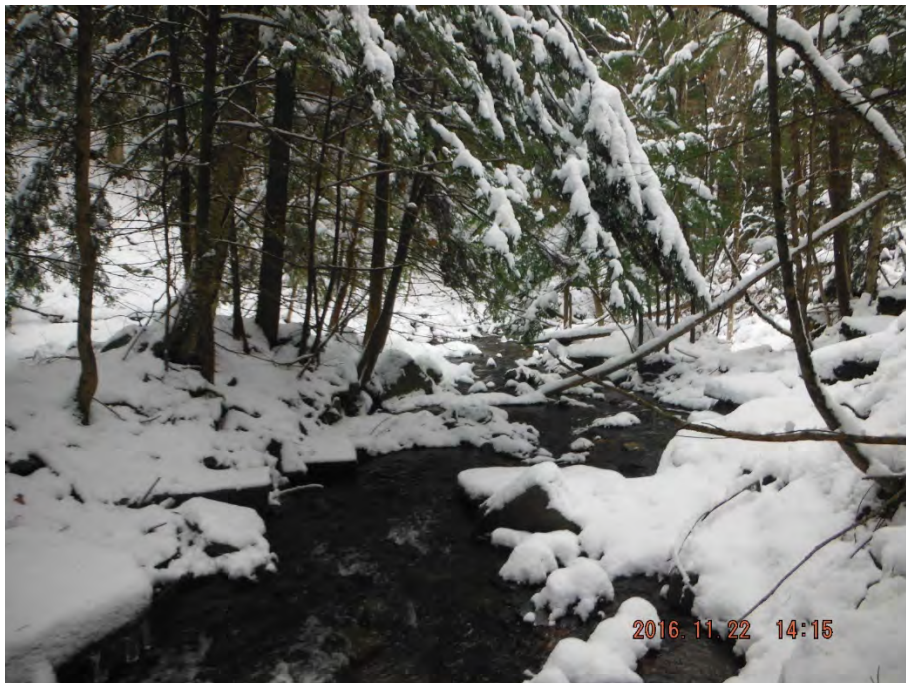
**Main Branch at STA 90+00
Confined hemlock ravine
November 22, 2016**

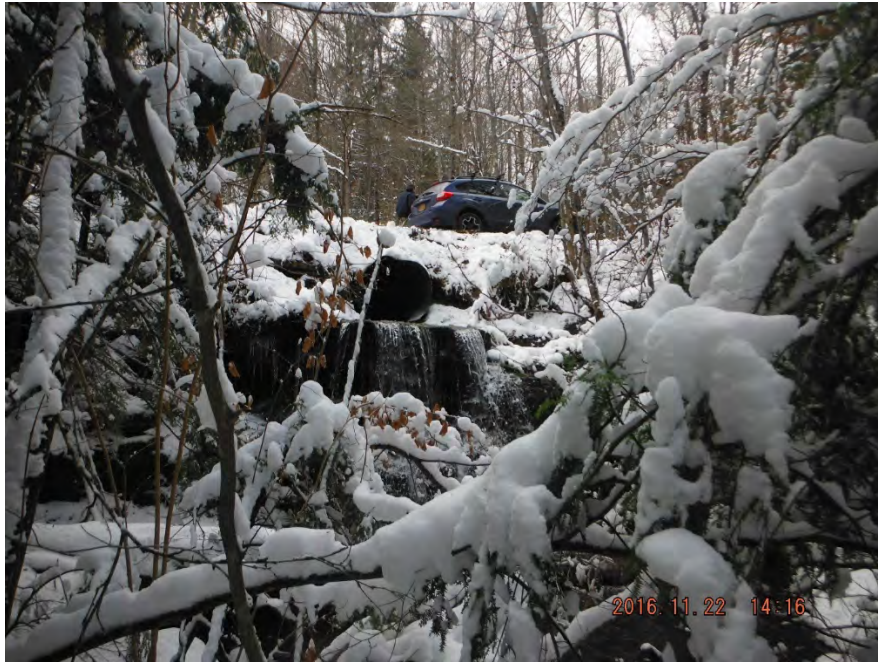
Main Branch at STA 97+00
Culvert crossing at Armlin Hill Road, viewed from downstream
November 22, 2016
