Franklinton Vlaie Tributary Improvement Study

**Technical Report and Recommendations
Town of Broome, Schoharie County, New York
March 2018**

MMI #6108-01-04

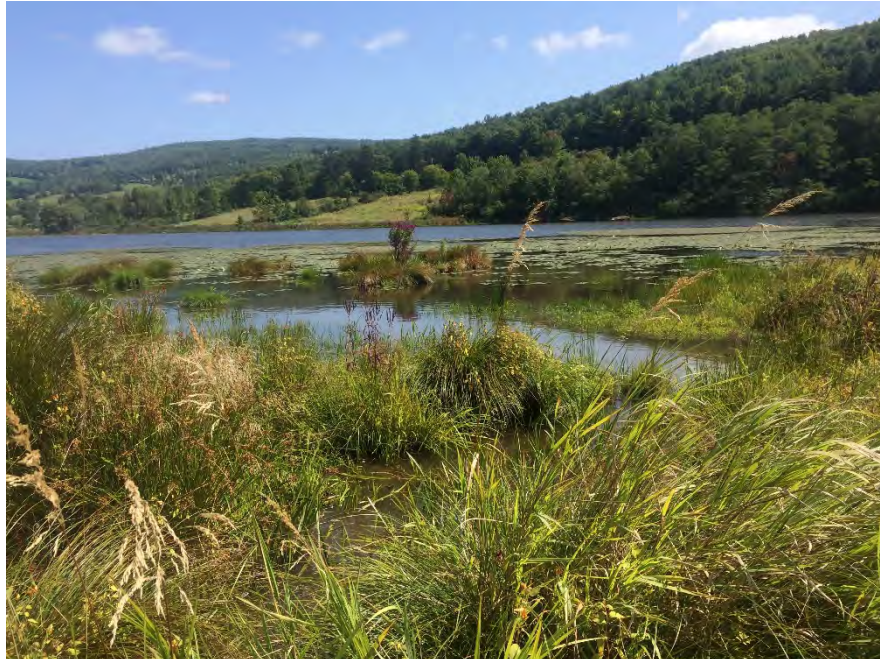
Main Branch at STA 9+00
On alluvial fan near outlet to Vlaie
March 7, 2017

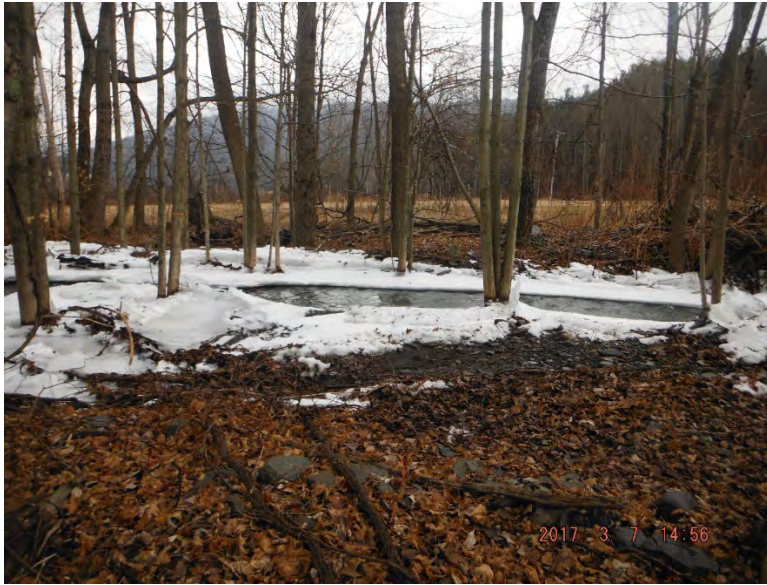
Main Branch at STA 9+00
On alluvial fan near outlet to Vlaie
March 7, 2017

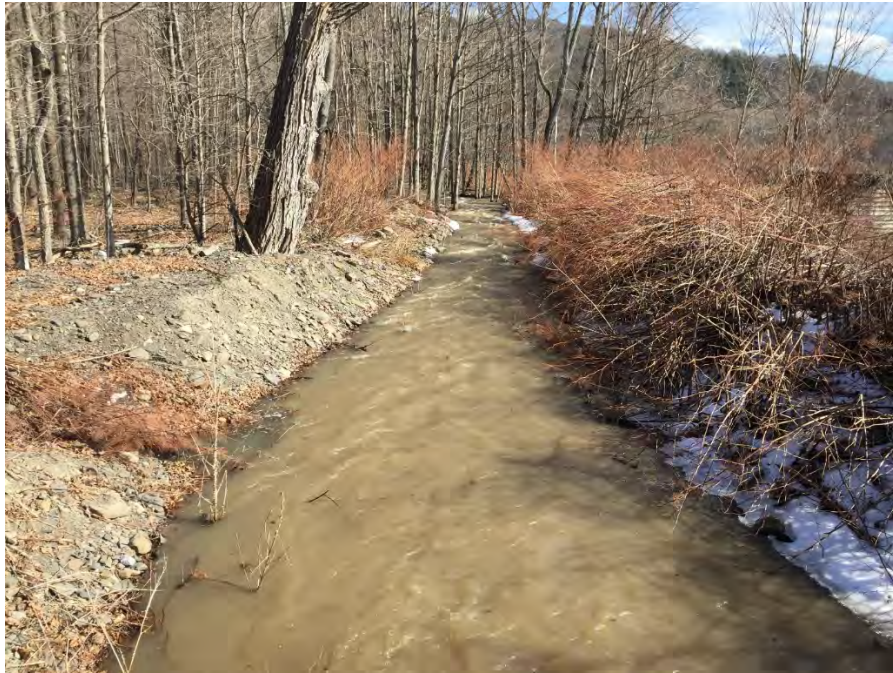
Main Branch at STA 10+00
Downstream of Woods Road Culvert

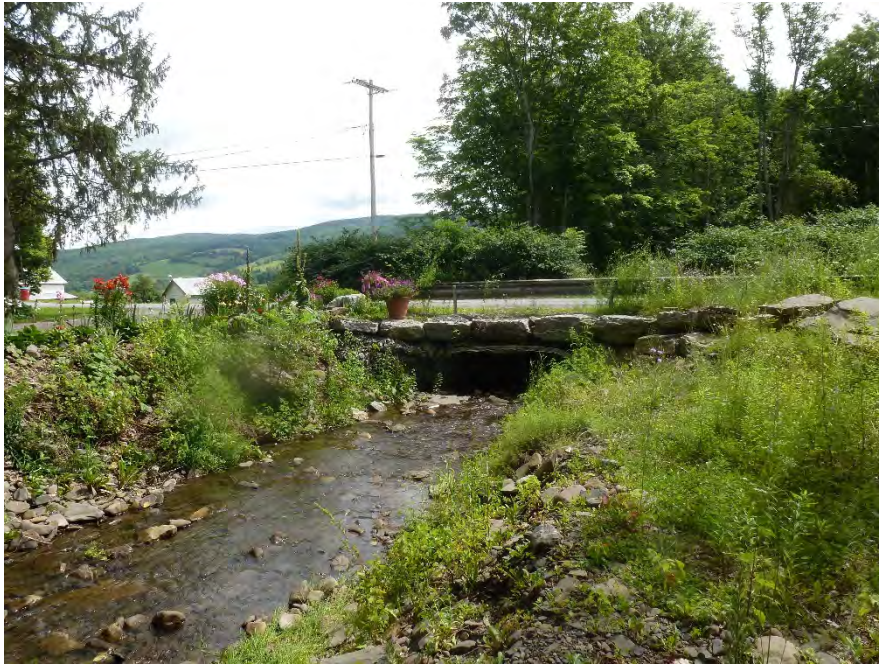
Main Branch at STA 15+00
View looking downstream towards culvert from below falls
March 7, 2017

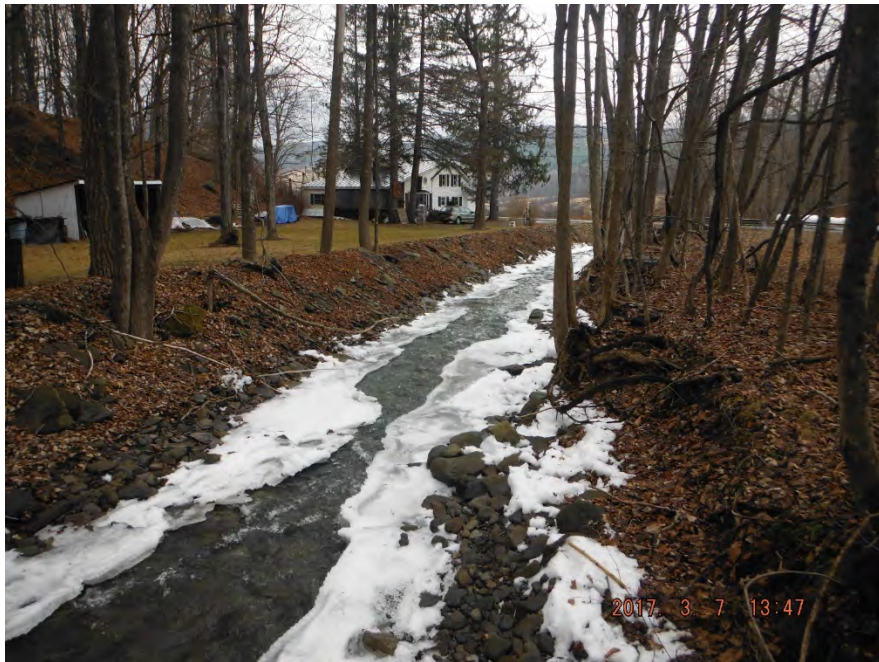
Main Branch at STA 15+00
View looking downstream towards culvert from below falls
March 7, 2017

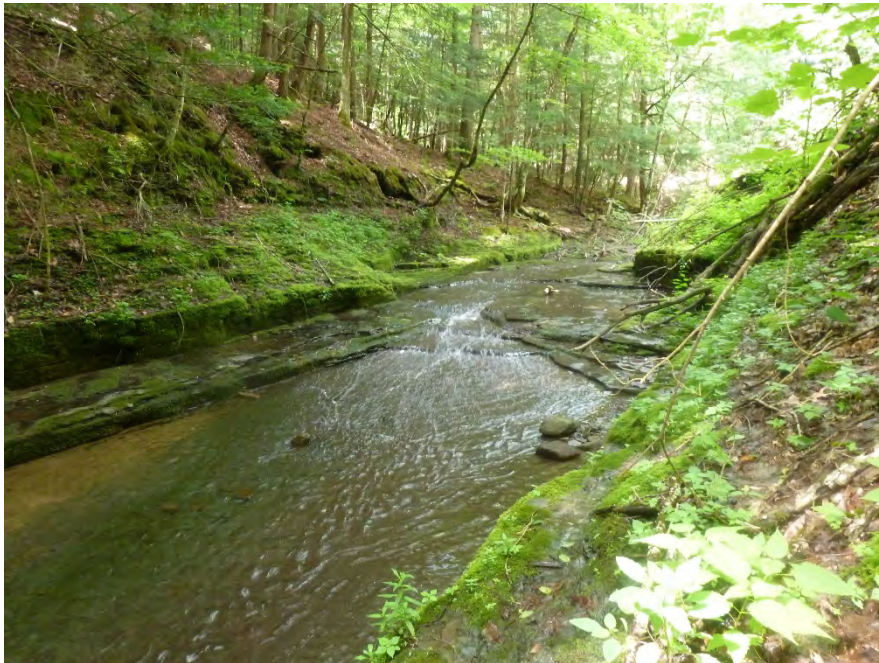
**Main Branch in Gorge
Trout in Pool**

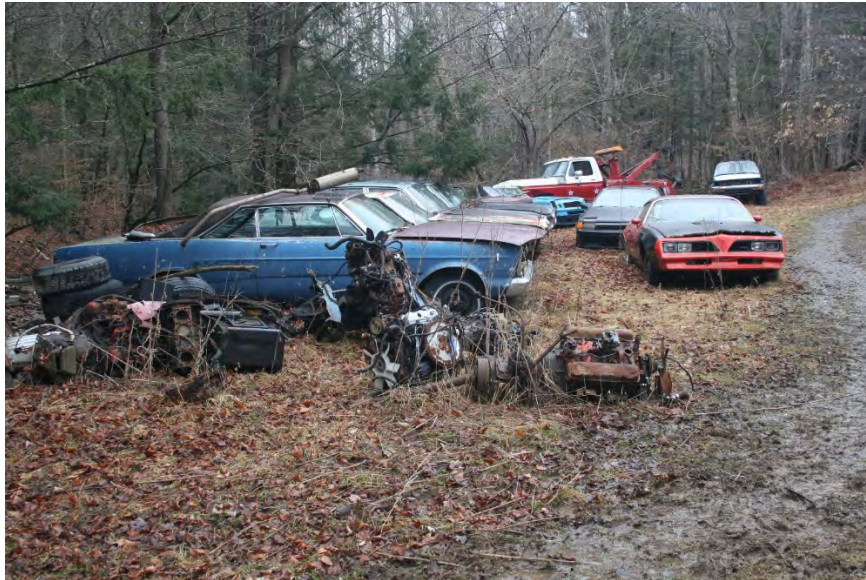
**Junked cars and engine blocks near North Branch
March 7, 2017**

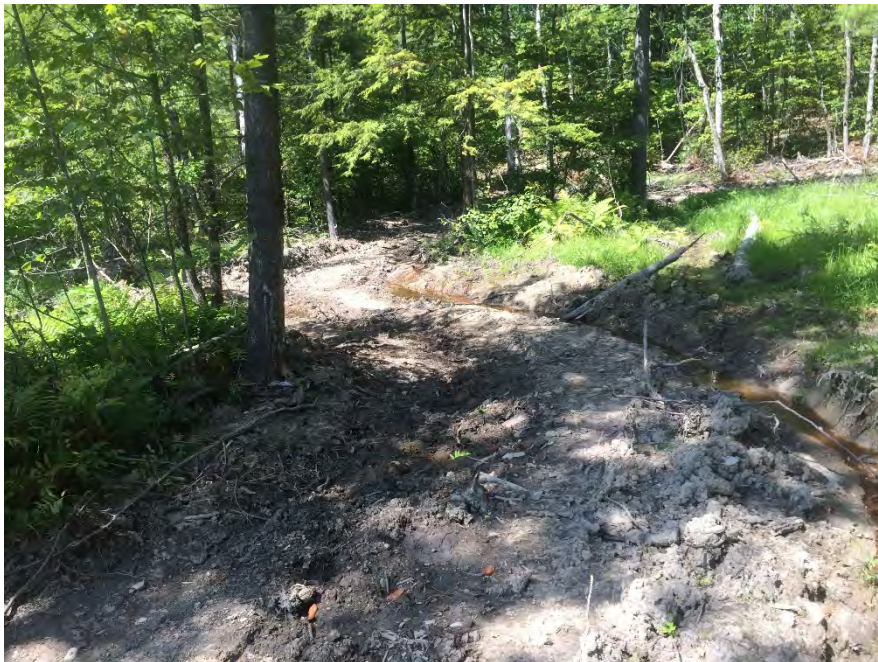
About 94% of the watershed is forested. Portions along the upper half of the northern tributary have been logged. Improper logging practices have left steep eroded paths through forest and muddy, eroded access roads through wetlands and near the stream. Some areas are severely eroded.

Logging Road along North Branch

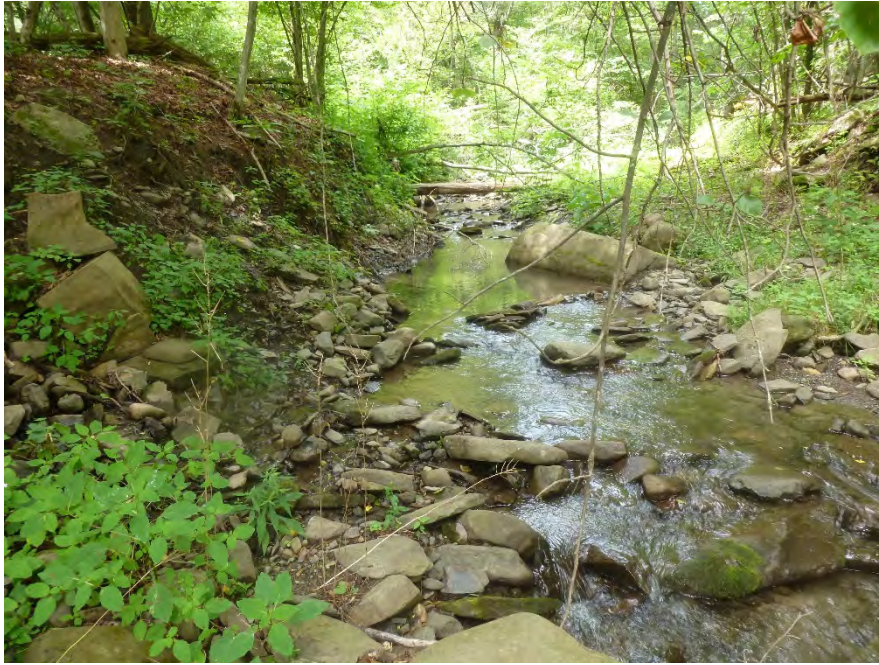
North Branch looking Upstream from Confluence
